ERDC/CRREL TR-03-17

Design and Operational Issues While Tunneling in Firn at the South Pole Station

Michael Walsh

September 2003

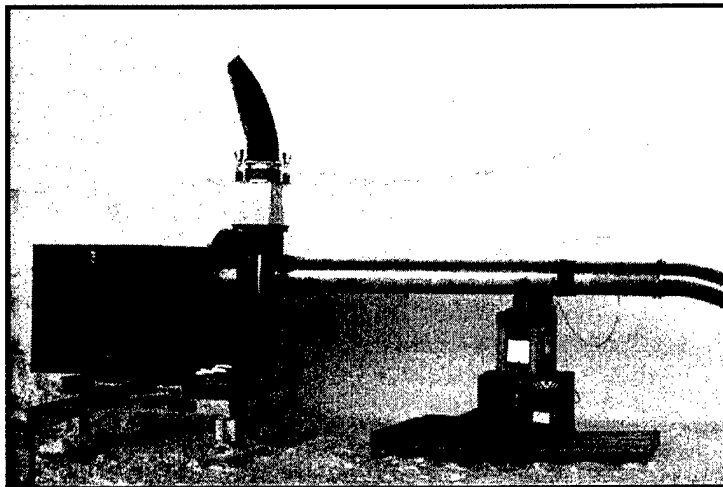
Figure 7. Expandable straight mixing tube at centrifugal fan inlet (photo, M.R. Walsh).
